# ASSESSMENT REPORT TYRE RECAPPING FACILITY AMPARA

**Prepared for: Sri Lanka Transport Board**

**Prepared by: Machine Mech Engineering**

**Date of Visit: August 7, 2025**

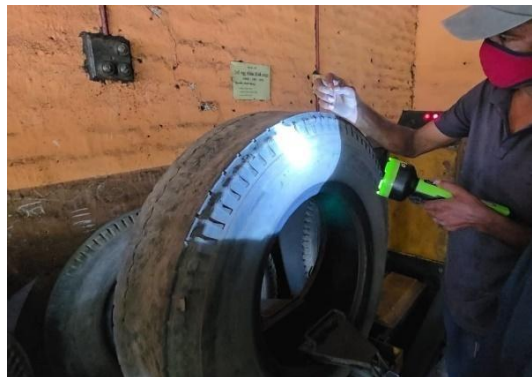
*Figure 4: Tyre inspection*

The inspection machine area lacks sufficient fixed lighting and currently relies on a handheld light, which is inadequate for detecting small cuts, cracks, or embedded objects. Overhead and side-mounted lighting should be installed for consistent illumination.

- Install overhead and side-mounted lighting in the inspection area to ensure proper visibility for detecting tyre defects.
- Replace the finger-based method with the metal-piece method to accurately identify internal tyre defects by sound. The facility should implement this method immediately.

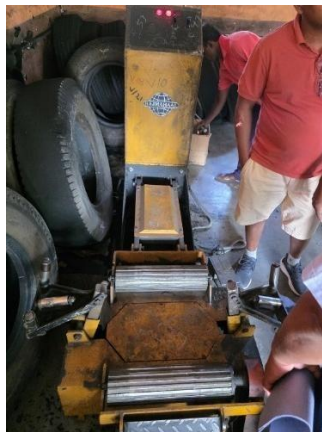
*Figure 5: Initial Inspection Machine*

- The standard practice of using a metal piece to check worn tires by sound is not followed, reducing the accuracy of identifying internal defects.
- The inspection machine has a pneumatic cylinder for tyre height adjustment to improve operator ergonomics, but it is not in use. The condition of the cylinder, pneumatic lines, and control valves should be inspected and repaired or replaced if necessary.

- Inspect, repair, or replace the pneumatic cylinder, control valves, and pneumatic lines to restore the height adjustment functionality of the tyre inspection machine.

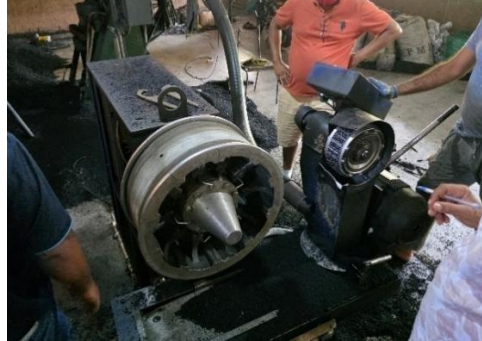
*Figure 6: Tyre buffing machine*

No maintenance has been carried out on this machine since its installation. Management has not ensured the machine is operating correctly before commencing production.

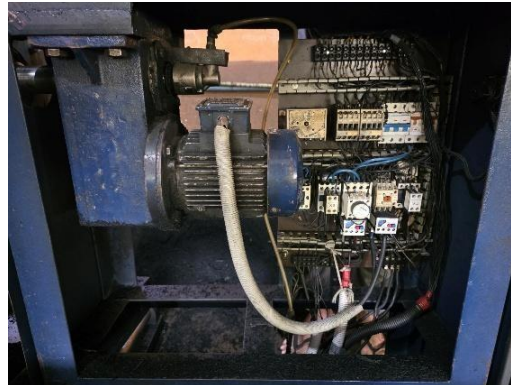
*Figure 7: Tyre rotating motor*

- The tyre rotating motor is getting heated. Due to this issue, the machine cannot be operated for extended periods.

- Replace the cooling fan or check the power transmission of the tyre rotating motor to prevent overheating and enable extended operation.
- Repair pneumatic leaks and install missing valves to maintain proper air pressure during buffing.
- Replace the damaged rim flap to prevent air leakage and ensure correct tyre pressure.
- Realign and repair the buffing cutter holding bed to ensure uniform cutting and maintain tyre quality.

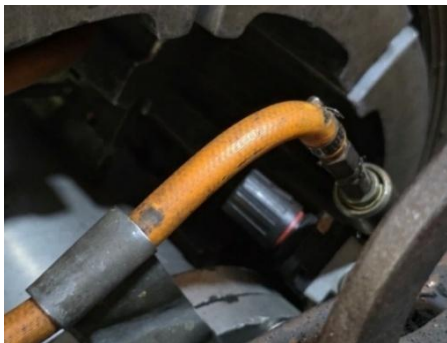
- The pneumatic tubes are leaking, and some required valves are missing. This results in insufficient air pressure during the buffing process, which can affect tyre quality. This issue should be fixed immediately.

*Figure 8: Pneumatic line is leaking.*

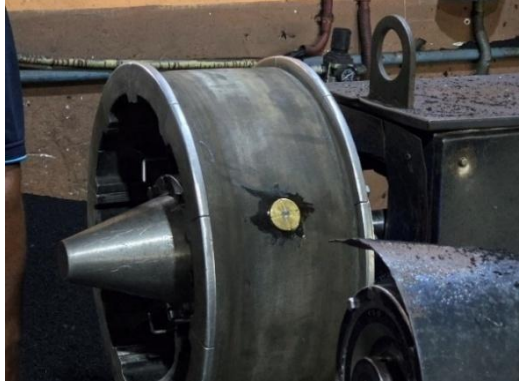
*Figure 9: Rim flap damage*

- The rim flap (rubber lining on the rim) is damaged, causing air leakage and compromising the ability to maintain proper air pressure in the tyre during buffing.

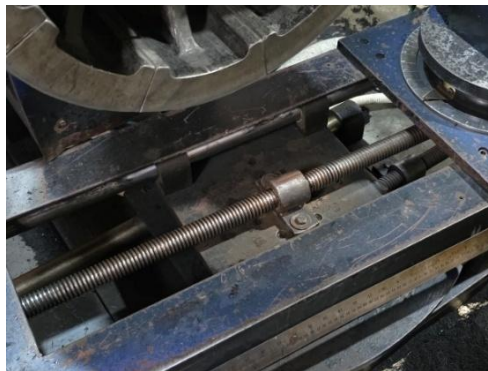
- The buffing cutter holding bed and tyre centre are not properly aligned. As this machine performs a critical function for tyre quality, unequal cutting on the tyre surface can occur. Therefore, the machine must be repaired or replaced.

*Figure 10: Centre of the tyre and centre of the cutting bed are not aligned*

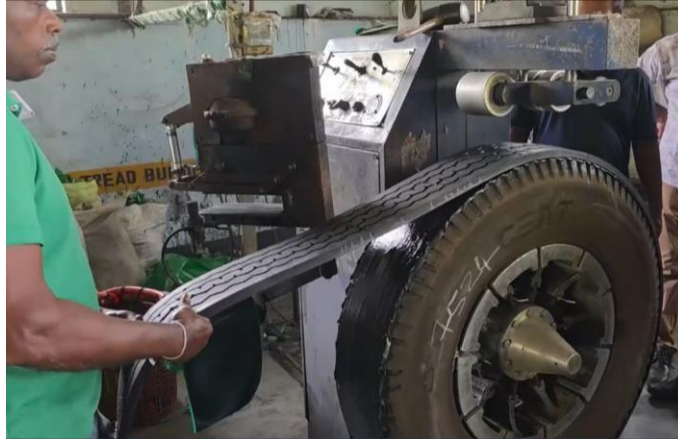
*Figure 11: Tread Building Machine*

As with other machines, no maintenance has been carried out on this one. As a result, workers are attaching threads to the tyres without ensuring the machine is operating correctly, which leads to the production of defective tyres.

- Repair and realign the tread liner cutter to ensure cuts are at correct angles, preserving liner fit and overall tyre quality.

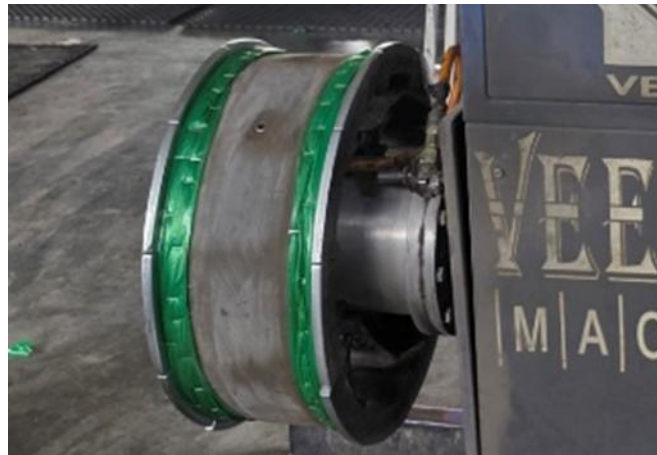
*Figure 12: Air leak at rim/air filter area*

- Tread is not bonding properly due to air leaks at the rim and air filter area. Tyres must be pressurized during tread building to ensure proper bonding between the casing and the tread liner.

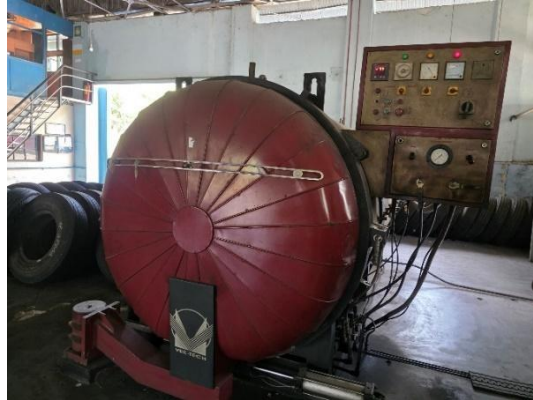
Figure 13: 11 Tyre Electric curing chamber

The single 11-tyre electric curing chamber was identified as a bottleneck in the production process. Currently, only 6 cycles per day are run, producing 66 tyres, despite continuous day-and-night operation. Several faults were observed, which limit the number of cycles and affect the final tyre quality.

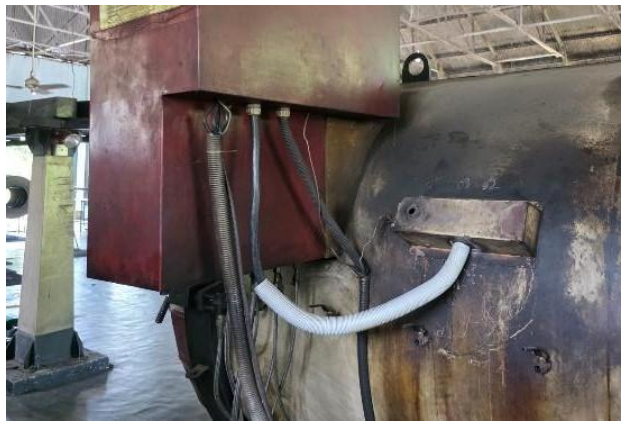
- Heating coils are not properly connected, causing electrical sparks. This is a serious safety hazard and must be corrected immediately. Operators reported previous fire incidents due to these sparks.

Figure 14: Improperly connected coils causing electrical sparks

- Reconnect and secure all heating coils properly to eliminate electrical sparks, mitigate fire hazards, and ensure all coils function correctly.
- Replace the inaccurate temperature indicator with a calibrated device to maintain consistent tyre curing at 125 °C.
- Increase the number of curing tubes, envelopes, and hangers to at least 25 each (including standby) to allow continuous batch preparation, reduce idle time, and minimize energy waste.
- Use high-quality curing tubes capable of at least 100 cycles to ensure reliability and consistent tyre quality, reducing the risk of defective products.
- Upgrade the compressed air supply line to provide adequate flow and pressure, reducing cycle duration and improving overall curing consistency.

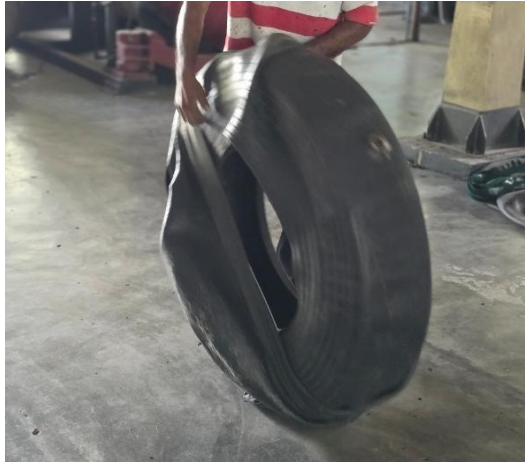
*Figure 15: Enveloped tyre*

- According to operators, the current tubes can only be used to cure approximately 30 tyres before replacement, which indicates poor quality. Normally, tubes should last around 100 cycles to ensure consistent quality and reduce downtime.

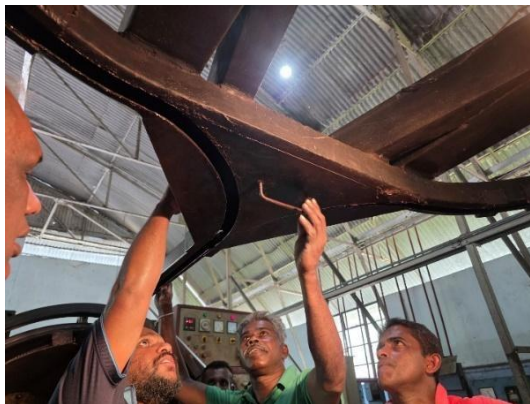
- Compressed airflow is insufficient, affecting curing efficiency and increasing cycle time. Modifications are required to reduce cycle duration.
- No maintenance has been performed on the monorail system, and worn-out parts were observed, which could affect both operation and safety.

*Figure 16: Worn-out parts observed due to lack of maintenance*

- Establish a structured preventive maintenance program to ensure all machinery is serviced regularly, minimizing unexpected breakdowns and improving operational efficiency. Engage external SLTB technicians as needed.
- Implement proper corrective maintenance procedures, avoiding temporary fixes and ensuring repairs follow manufacturer specifications.
- Maintain an adequate inventory of critical spare parts and provide the necessary tools for all major equipment to reduce downtime during repairs.

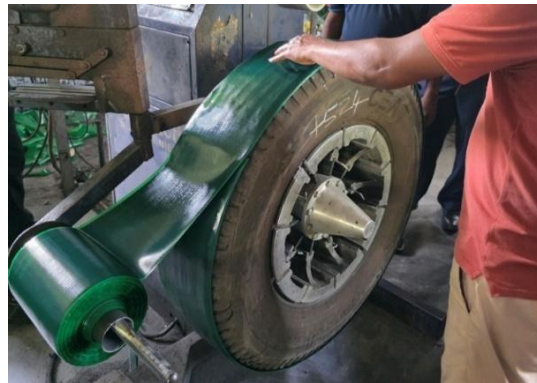
- Current cushion gum is supplied at 220 mm, which is wider than the tread belt, causing higher cost and difficulty in final inspection. Future orders must supply 200 mm cushion gum to match the tread belt and avoid gaps or waste. No proper system currently exists for checking cushion gum quality.

*Figure 17: Excess width of cushion gum causing gaps and difficulty in inspection.*

- Establish a quality verification system for cushion gum at delivery, including measurement of width and thickness, and provide operators with training to identify low-quality gum manually using hand-applied force (tensile testing).
- The thickness and the width should be as follows;

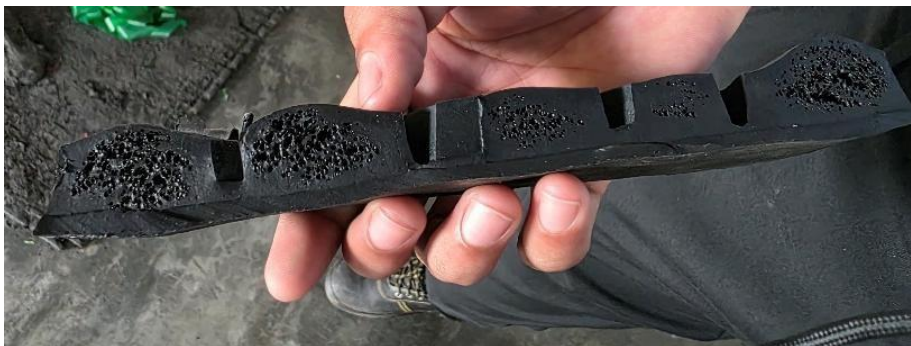
- Proper tools for checking tread liner quality are not available. Poor-quality, contaminated, and undercured liners were observed, and operators are not consistently rejecting substandard material.

*Figure 18: Air bubbles in tread liner*

- Equip the facility with vernier calipers and hardness meters for accurate checks of tread liner quality.
- Operators should receive further training and be encouraged to reject low-quality raw materials.
- A test report must be given prior to purchase and a random sample checking system should be introduced for following parameters.

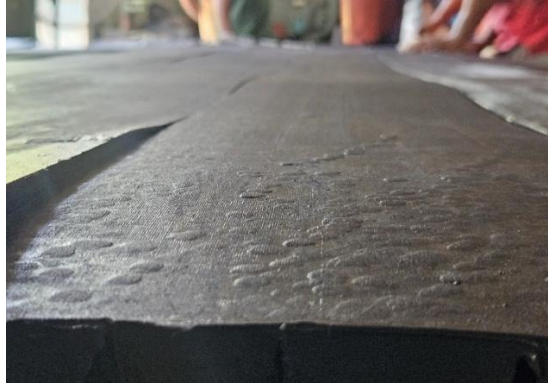
*Figure 19: Tread liner surface with insufficient roughness*

- A sample of texture (the roughness of the bonding surface) must be shown prior to purchase and a random sample checking system should be introduced against that same sample.
- Width of the sample must be according to the order form.  
i.e. 195mm, 190mm, 170mm, 165mm

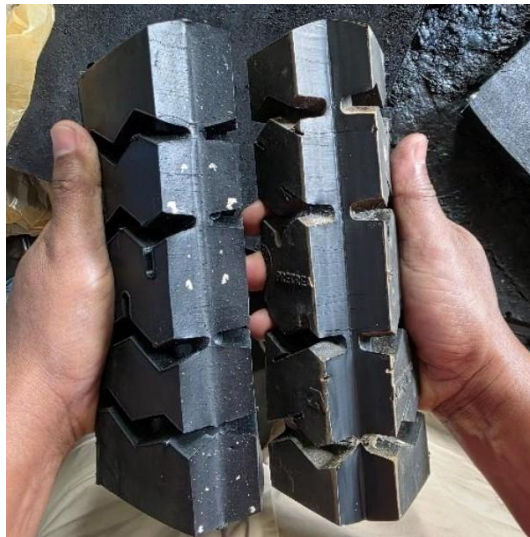
*Figure 20: Tread liner with visible contamination affecting quality*

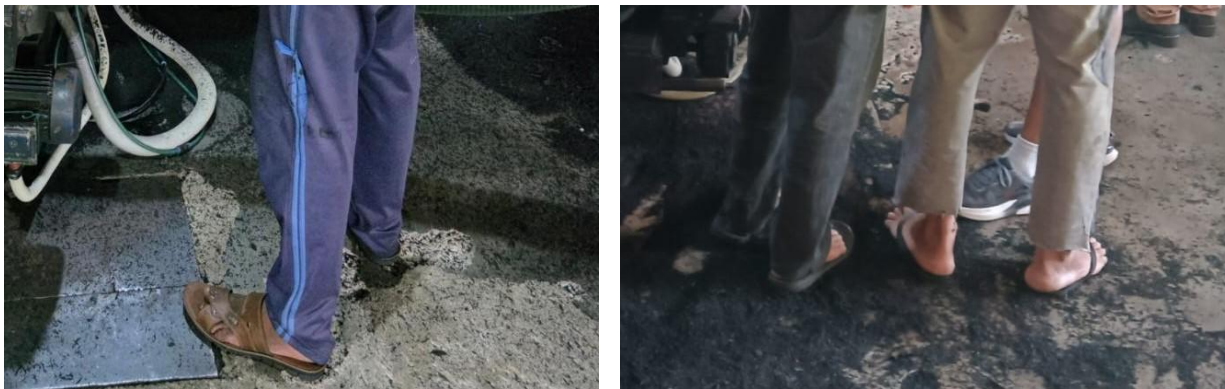
During the plant visit, it was observed that PPE usage was very limited. Most operators relied only on oven gloves during curing operations, while other essential protective equipment such as safety gloves, safety shoes, and goggles were neither provided nor used. In the buffing section, noise levels were considerably high, yet hearing protection was not available. Additionally, work areas were not clearly marked with safety zones and caution signs, further increasing the risk of accidents.

*Figure 21: Operators working without safety shoes*

- Implement strict tyre pressurization procedures, ensuring tyres are pressurized only after the curing chamber door is fully closed to eliminate potential hazards.
- Conduct a safety training session for all operators to reinforce proper practices, hazard awareness, and adherence to standard operating procedures.
- Provide and enforce the use of comprehensive personal protective equipment (PPE), including dust masks, safety gloves, heat-resistant gloves, safety shoes, goggles, ear protection, and overalls, to minimize the risk of injury.
- Clearly mark work areas with safety zones, caution signs, and hazard warnings to guide safe operations and reduce accidental exposure to risks.
- Ensure the facility is equipped with a well-maintained first aid box for immediate response to any incidents.

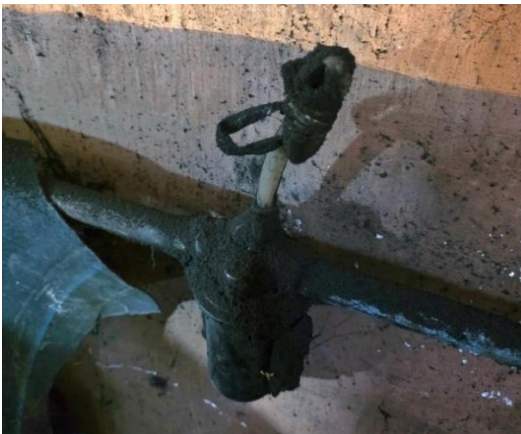
No spare parts stock is maintained, and there are no dedicated mechanical or electrical technicians available in the plant. As a result, maintenance is delayed or performed by operators, which can compromise both machine performance and safety.

*Figure 22: Airline leaks not prepared properly*

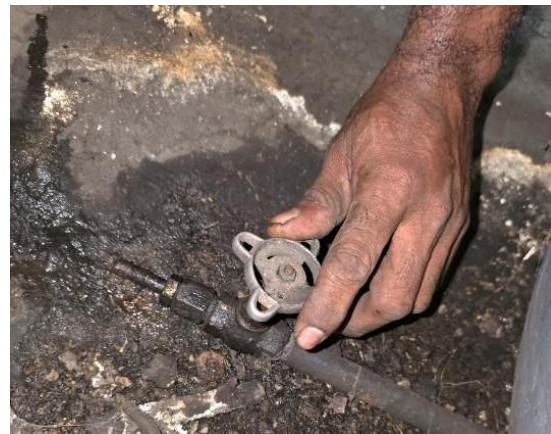
*Figure 23: compressor bottom valve needs to replace*

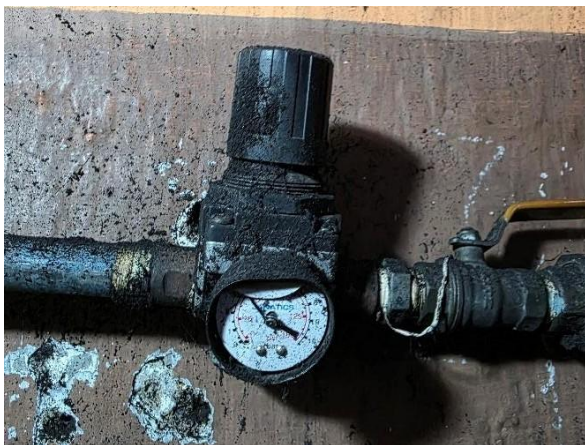
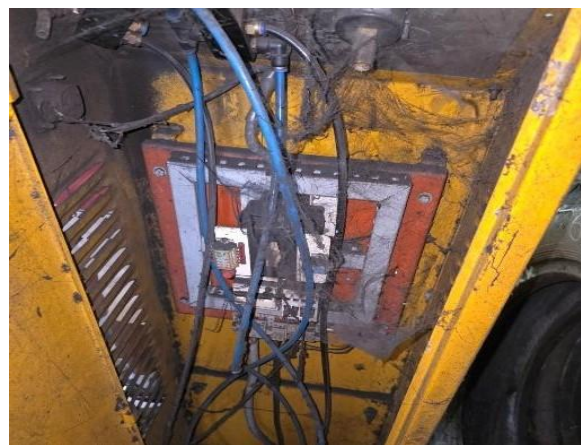
During the plant visit, it was observed that preventive and corrective maintenance practices are not being adequately implemented. Machinery is frequently operated under unreliable conditions, with temporary fixes used to keep equipment running. This approach increases the risk of breakdowns, reduces operational efficiency, and contributes to the production of substandard tyres.

*Figure 24: Maintenance not followed*

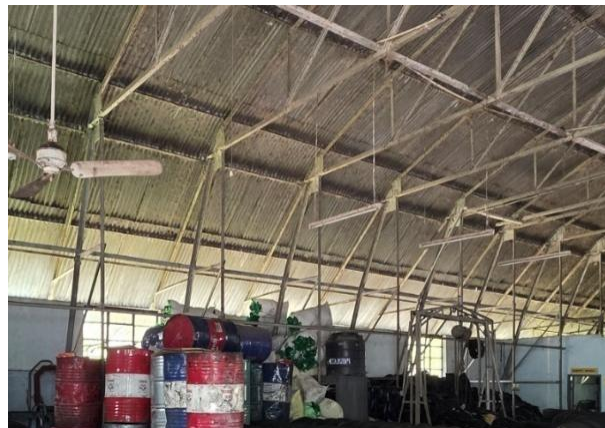
In addition, rubber waste is being stored inside the building, occupying valuable production space and creating a fire hazard risk, while buffed tires are left outside without proper storage arrangements.

*Figure 25: Improper storage of rubber waste within the processing area*

- Replace all existing fire cylinders and fire protection equipment with new, certified units, ensuring proper coverage until a service agreement with a reputable company is established.
- Conduct training for all operators and staff on the correct use of fire safety equipment and emergency response procedures.
- Relocate rubber waste currently stored in the main processing building for sale or safe storage, maintaining a clean and hazard-free work environment.
